“END-OF-THE-PIPE” MATERIAL RECOVERY TO REDUCE WASTE DISPOSAL AND TO MOTIVATE THE INFORMAL SECTOR TO PARTICIPATE IN SITE IMPROVEMENTS AT THE CALAJUNAN DUMPSITE IN ILOILO CITY, PANAY, PHILIPPINES

“*end-of-the-pipe*” material recovery system was proposed. The presented research summarizes the set up and findings of a 20-day segregation test at the local dumpsite, which was conducted together with 30 local waste pickers using a mechanical recovery facility. The latter consisted of an input conveyor belt, a trommel screen and a ring-belt system for manual segregation at the local dumpsite.

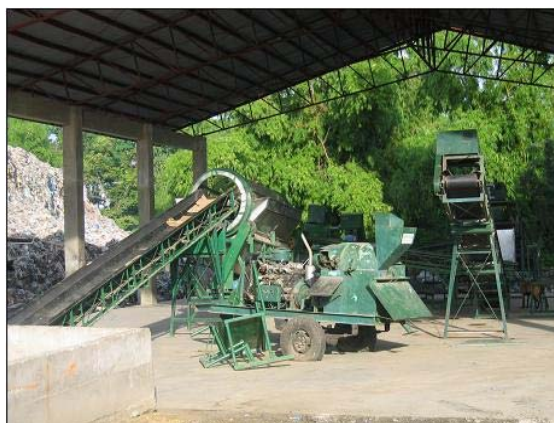
MRF at the Calajunan disposal site

The MRF consists of the processing building, the input / receiving area, in-feed conveyor system, trommel screen, and a 4 – way conveyor system, whereas each conveyor belt is powered by an individual motor. At the output side, a hammer mill is established as an option for further processing as part of the system. However, the hammer mill was not used during the test run. The MRF was designed to process up to 40 tons of wastes per day according to the technology provider. The conditions under which this output could be achieved were not known.

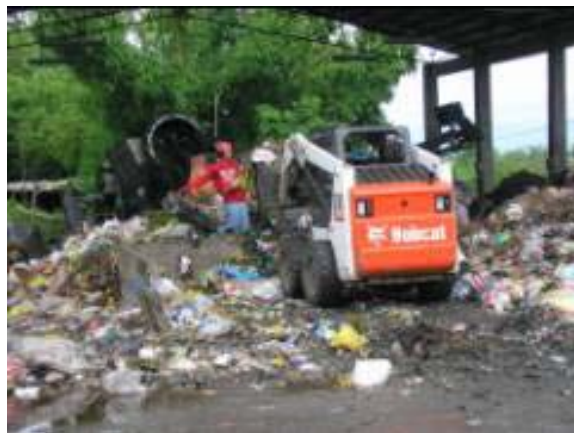
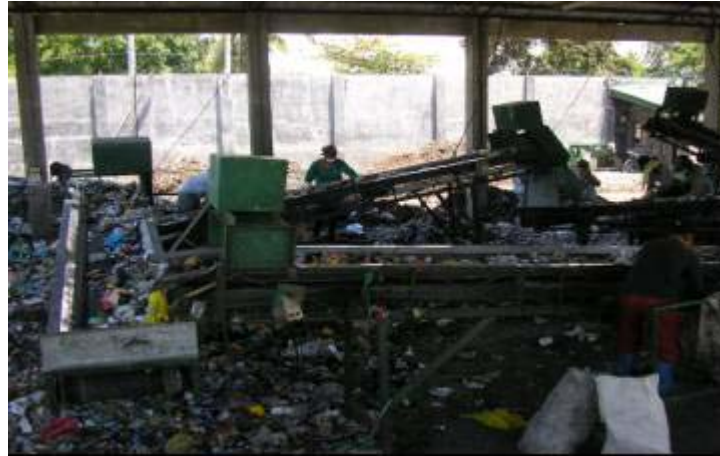
From the input area, the waste materials were transferred to the in-feed conveyor, from there into the rotating trommel, where a waste segregation in an undersize fraction (waste components < 1 inch=undersize and waste components > 1 inch=oversize) was conducted.

During the process, the fine materials were screened out and transported to a hopper/funnel. These fine materials were then collected and put into a wooden box at the output end of the conveyor system. The wooden box was emptied when full and the content weighed and recorded. Parallel, all materials of the oversize fraction which passed the trommel screen, were forwarded to the four-way conveyor system for further manual segregation. A “bottleneck” at this location and along the conveyor belts was identified during the test especially when the waste materials were wet.

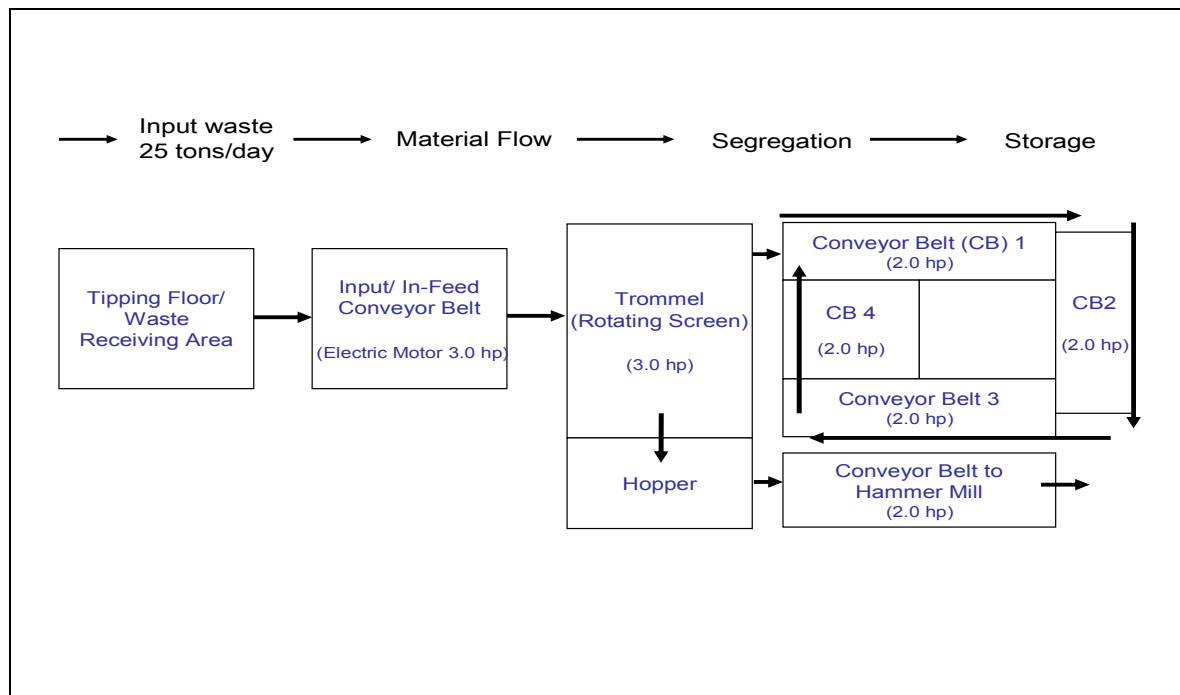
Working side by side along the conveyor belts, the workers separated the various recyclables, biodegradables, and residual wastes manually. The system was designed to allow continuous movement of waste materials from one conveyor to another in a loop until all the wastes could be sorted out properly. During the test run, at least 6 workers were assigned to sort the wastes along the square conveyor belts. Wastes were categorized, packed and weighed accordingly. Sellable materials were sold directly to the nearby junk shops after the shift while residuals were collected, weighed, recorded and disposed into the dumpsite. The chart below shows the recovery and segregation process at the MRF facility.

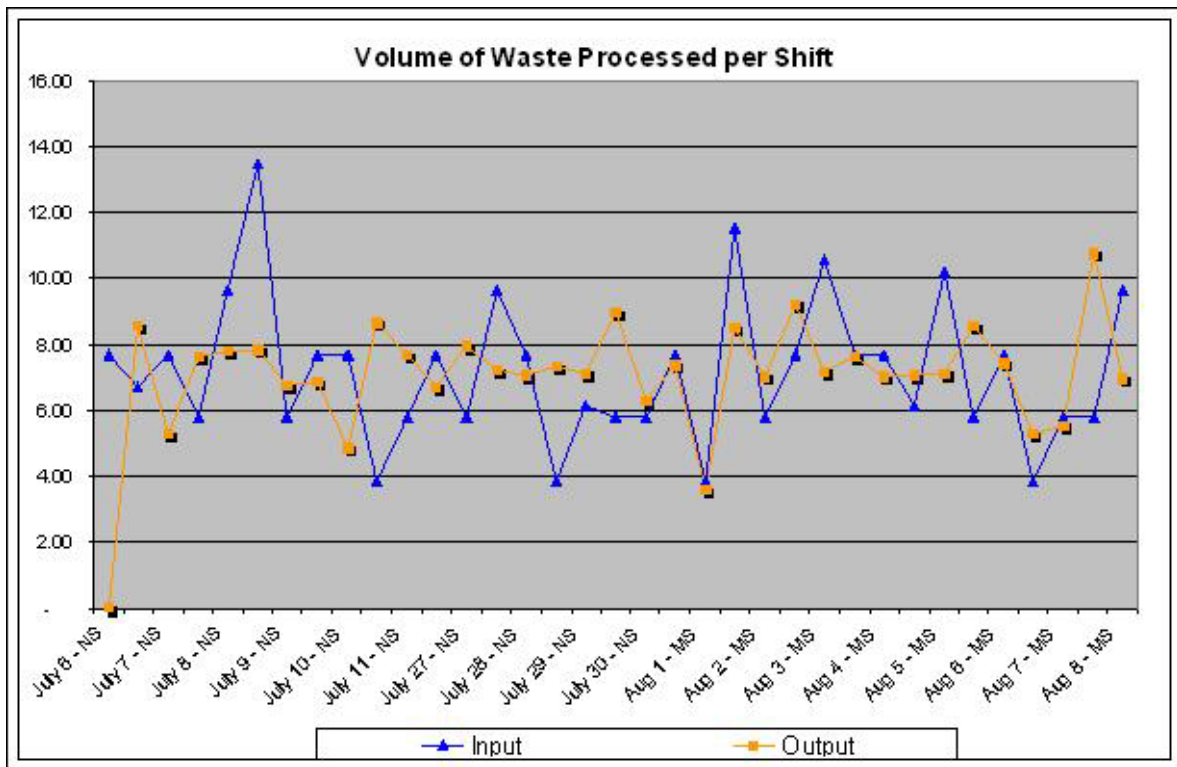
Waste delivered and processed during the 20-day Test varied significantly from day to day. The records revealed that daily wastes brought to the MRF facility varied from 3.85 to 13.48 tons. For the entire test duration, the total volume of processed wastes was estimated with 915 m³ equivalent to 251.6 tons based on a waste density of 275 kg/m³. From the input waste about 898 m³ or 246.9 tons or 98% were processed.

Based on the test data, the average quantity of waste processed per 8 – hour shift was 7.06 tons. Hence, the existing MRF may process 14.24 tons on a two-shift work cycle, which is only 35.6% of the manufacturers claimed capacity. The table below presents the total input and output data of the MRF test run. The daily amount of wastes processed during the test run varied in a range from 3.5 to 10.75 tons per shift as shown in the graph below. The test also revealed that the input materials were not totally processed within one shift. In many instances, wastes delivered at the beginning of a shift were processed in the succeeding shift. This fact may be one explanation for the observed differences in input and output weight on daily basis. Further reasons for the delayed processing will be discussed in the proceeding sections.

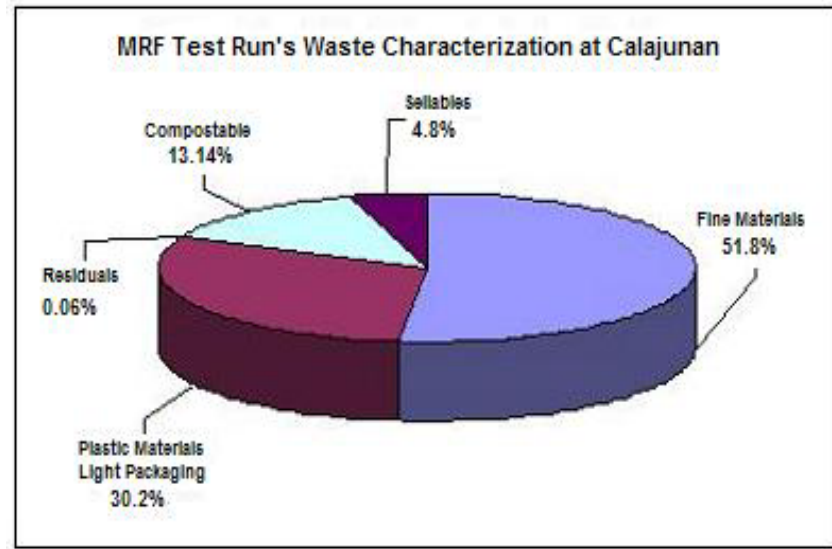
Results show that more than half or 51.8% of the total waste processed during the test were fine residuals. These fine materials are the wastes screened out from the trommel screen measuring < 1-inch diameter. This fraction is composed of combined waste materials, mostly soily like small waste particles. This waste fraction could be used as soil cover at the sanitary landfill.

About 30.21% of the wastes segregated during the test run were light packaging and synthetic, often combined materials. These synthetic materials are not sellable at present. Together with the 0.06% residual wastes and the fine residuals, these materials were disposed at the dumpsite. Hence, about 82.06% of the delivered wastes had to be disposed after the test.

Compostable materials such as garden and vegetable residues and some kitchen wastes accounted for 13.14% of the total wastes processed while the residual wastes out of the oversize fraction > 1 inch accounted for 0.06%. Residual wastes consisted of non-reusable materials such as soiled disposable diapers, napkins and other unclassified materials.

In average, 4.8% of the wastes were sellable components such as bottles, plastics, paper and metals. Consequently, these materials were the most sought materials by the wastepickers as their daily income depends on them. Such segregated materials were sold during the following day, whereas the income was divided among the involved wastepickers per shift. In average, every worker received a daily income of P75 per shift in addition to the P100 per day allowance provided per person and per shift for participating in the test run. Reported highest and lowest daily earnings from the recovered sellable materials are P90 (1.8 US-\$) and P59 (1.18 US-\$) per person respectively. Based on the “waste-pickers-report”, the amount of sellable materials dumped at the dumpsite has decreased over the last few years. This may be an indicator for increasing material recovery at household and barangay level, but also during the collection process. Many people are now collecting sellable materials at source including the garbage collectors.

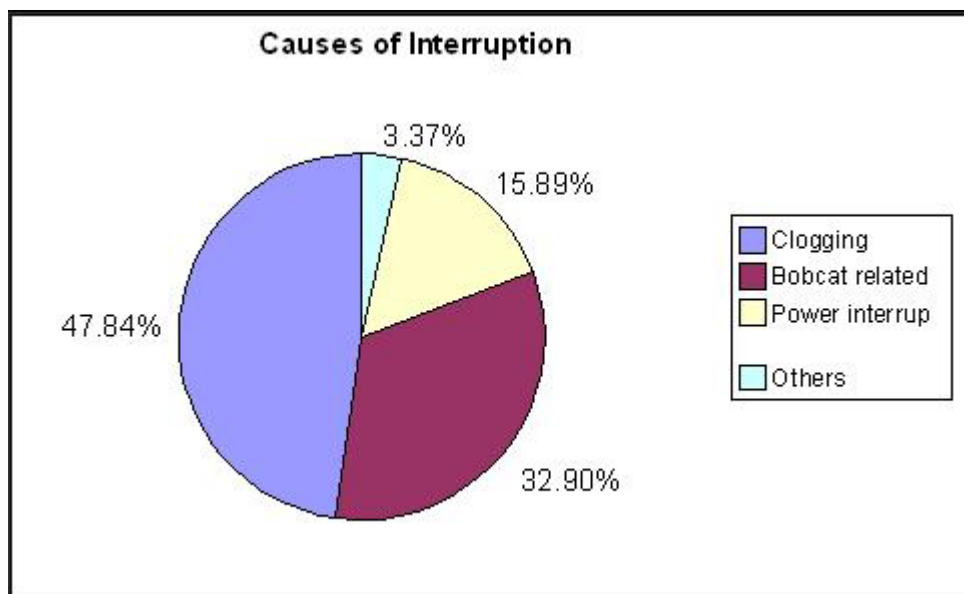
During the 20-day test run, the performance of the MRF facility was mostly affected by the clogging of the system, overflow of wastes out of the conveyor, and break downs of the mini loader (Bobcat). As shown in the figure below, disruptions due to clogging and overflow accounted to 47.84 percent of the total time of interruptions. This was followed by the mini loader's dysfunction, mostly due to often punctured rubber tires, which accounted for 32.9 percent of total time interruptions. This caused delays for several hours, particularly if repair and tire replacement could not be performed immediately. Another cause of interruption was related to power supply (15.89 percent), and 3.37 percent were attributed to other parts of the system such as trommel screen clogging and personnel related delays.

In terms of frequency and length of interruptions observed during the 20-day test operation, the following table summarizes the aspects which most affected the system performance. Clogging and overflow of conveyor system accounted for 13.5 hours followed by the Bobcat break-downs with 9.3 hours. Correcting these two problems, the system performance could be increased by more than 7 %.

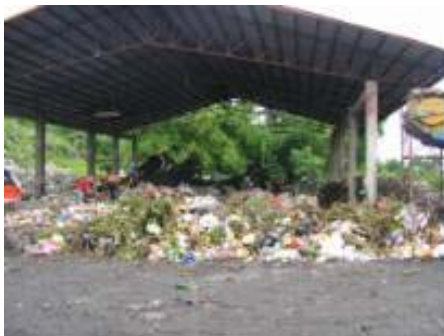
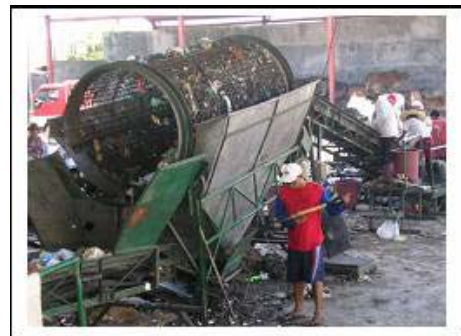
Tipping floor: The tipping floor, where the waste was received, was found to be insufficient to accommodate the input waste delivered for processing. No appropriate ramp was installed to receive the wastes. The absence of a properly designed receiving area hindered to move the wastes to the input conveyor and hence made the process more laborious and time consuming. The conveyor at the input side was too narrow to accommodate all the waste inputs, which often resulted in waste spillovers.

Trommel Screen: The hopper beneath the trommel was often clogged-up with wastes especially when the waste inputs were wet. The worker shown in the picture is banging the funnel board with a hard wood/object to remove the clogged waste materials that stick to the board.

Conveyor Belt: Clogging of the waste materials at the in-feed conveyor belt.

Funnel board/hopper: The funnel under the trommel screen was too small to accept all outscreened waste materials onward to the Hammer Mill.

- The current equipment set-up needs to be retrofitted to enhance the material recovery system, i.e., widening of conveyor belt, resizing of mesh, designing the receiving platform, and other MRF components such as the shredder and hammer mill;
